Federal Aviation Administration
Aircraft Certification Service
Small Airplane Directorate

**MITSUBISHI HEAVY INDUSTRIES
MU-2B SERIES AIRPLANE
FFFSR REPORT**

JUNE 27, 1997

**FAA/JCAB FACT FINDING FOCUSED SPECIAL
CERTIFICATION REVIEW TEAM**

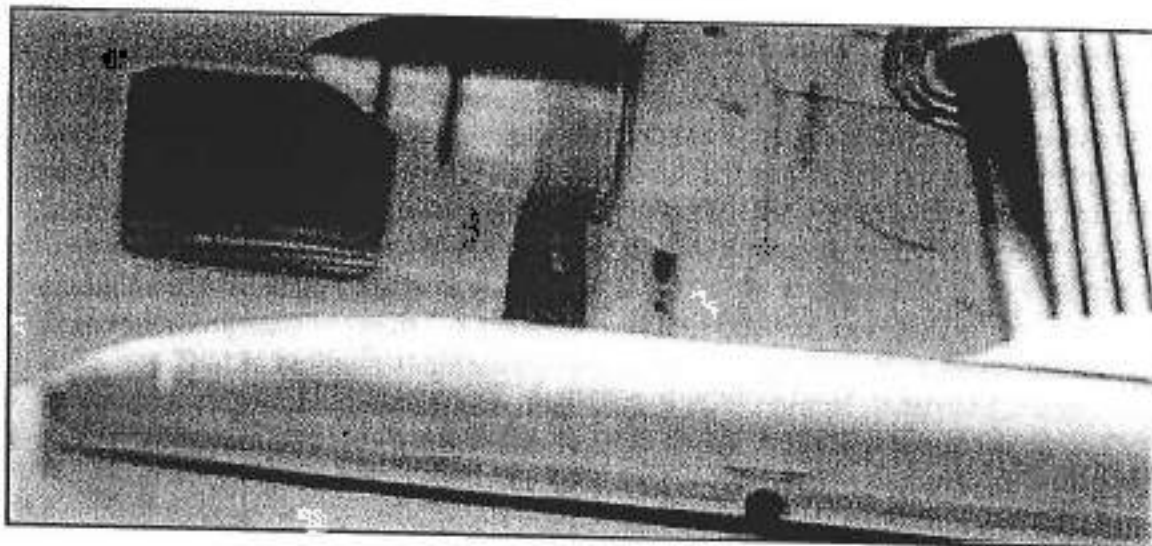
Figure I-1

Appendix C conditions were simulated on the long fuselage model MU-2B-60 in icing tanker flights conducted on April 26 and 27, 1996, at the AFFTC. Testing confirmed that Appendix C ice on the upper wing surface collected on the protected portion of the boots. Cycling of the boots removed all of the upper wing surface ice. Impingement on the lower surface was approximately 6 to 8 inches aft of the boot. Typical ice collection on the

airframe can be seen in figure I-1. These results are similar to those obtained in the 1984 SCR flights and are characterized by a drag increase without any observed control problem. During the original MU-2B icing certification and the 1984 SCR, these drag increases were judged to be acceptable based on the maximum power available. It must be understood that the tanker testing could not examine the effects of ice on the entire airplane simultaneously. The impingement on the MU-2B was also compared to another airplane (figure I-2) and the impingement characteristics were found to be consistent with the other airplane.

Ice impingement on MU-2B wing upper surface in icing tanker testing. The icing cloud contained droplets larger than Appendix C. The yellow color of the ice is from dye added to the tanker water to aid visual detection of the ice.

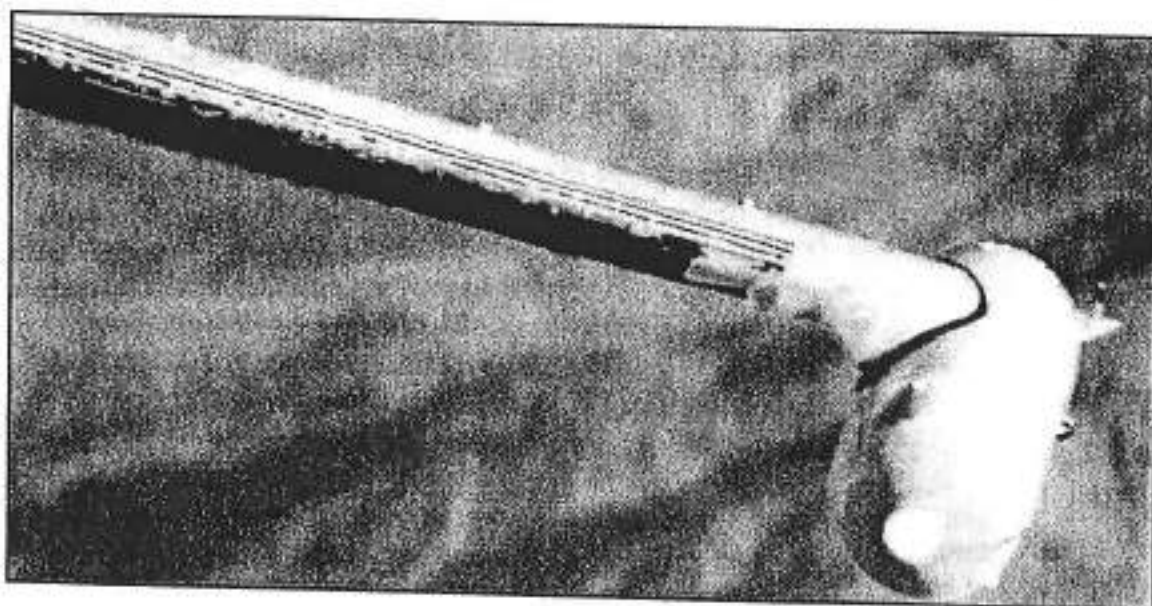
In SLD test conditions, the wing upper surface did collect some ice aft of the last active de-ice tube in a ridge with a ragged profile and sharp edges. After 20 minutes and several boot cycles, the ice ridge was observed from the chase plane to be stabilized with dimensions of approximately one inch wide and a maximum height of approximately $\frac{1}{4}$ inch (see figure I-3). The ridge was observed to build to approximately $\frac{1}{4}$ inch in height and then some spanwise portions would self-shed in the air stream. The growth and self-shedding process stabilized at a spanwise fraction coverage estimated at 40 percent. The artificial shape configuration shown in figure I-4 was developed to represent the SLD ice ridge aft of 7 percent chord on the upper surface of the wing. Ice buildup was not totally removed from the boots with every cycle of the boots. Some residual ice was observed on the wings as shown in figure I-5 and the horizontal stabilizer as shown in figure I-6.

*Figure I-3
MU-2B in SLD. Ice ridge is visible at aft upper edge of de-icing boots.*

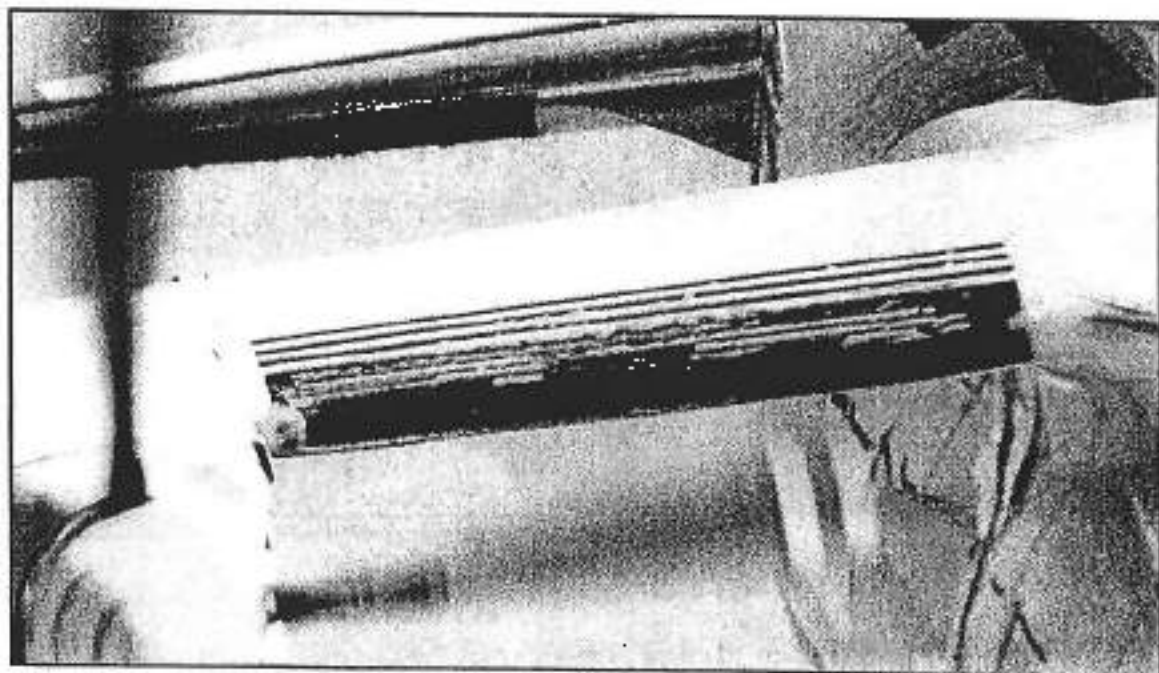
*Figure 1-5
MU-2B post-boot cycle residual ice on right inner wing in SLD. Note jagged edge of ice visible on lower surface of horizontal stabilizer.*

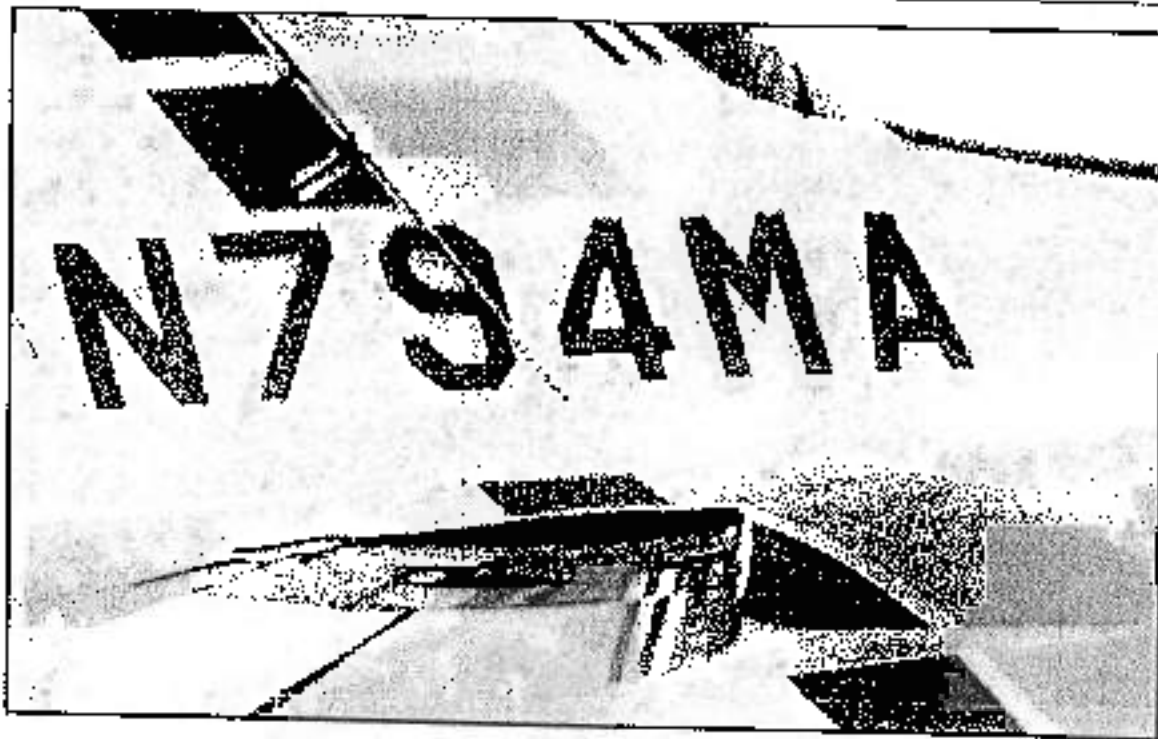
Figure 1-6

SLD ice on MU-2B lower surface of the right stabilizer with some ice visible aft to leading edge joint. Ice is visible on the vertical stabilizer.

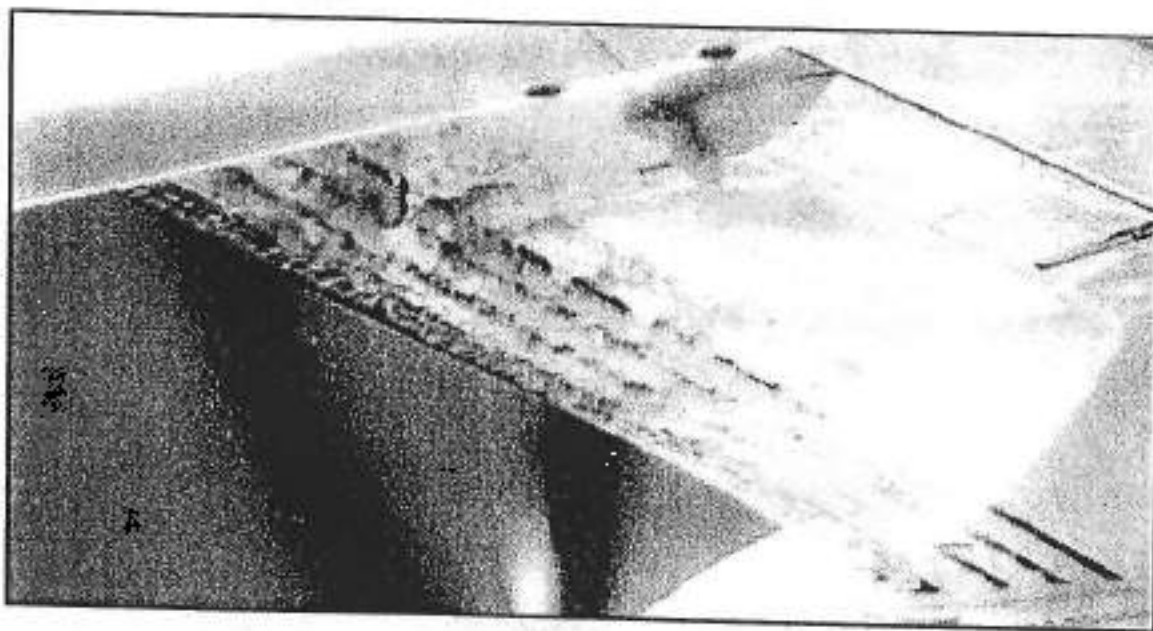
Figure 1-7

The lower wing surfaces collected ice asymmetrically, best defined as distributed ice elements to approximately 30 to 40 percent chord as shown in figure I-7; and aft of the up-going propeller blade, a sharp lip of ice immediately aft of the active portion of the de-icing boots that extended with smaller, more distributed ice elements, to approximately 30 to 40 percent chord as shown in figure I-8. Post-flight documentation of the lower wing surface

SLD ice on the MU-2B left wing lower surface.

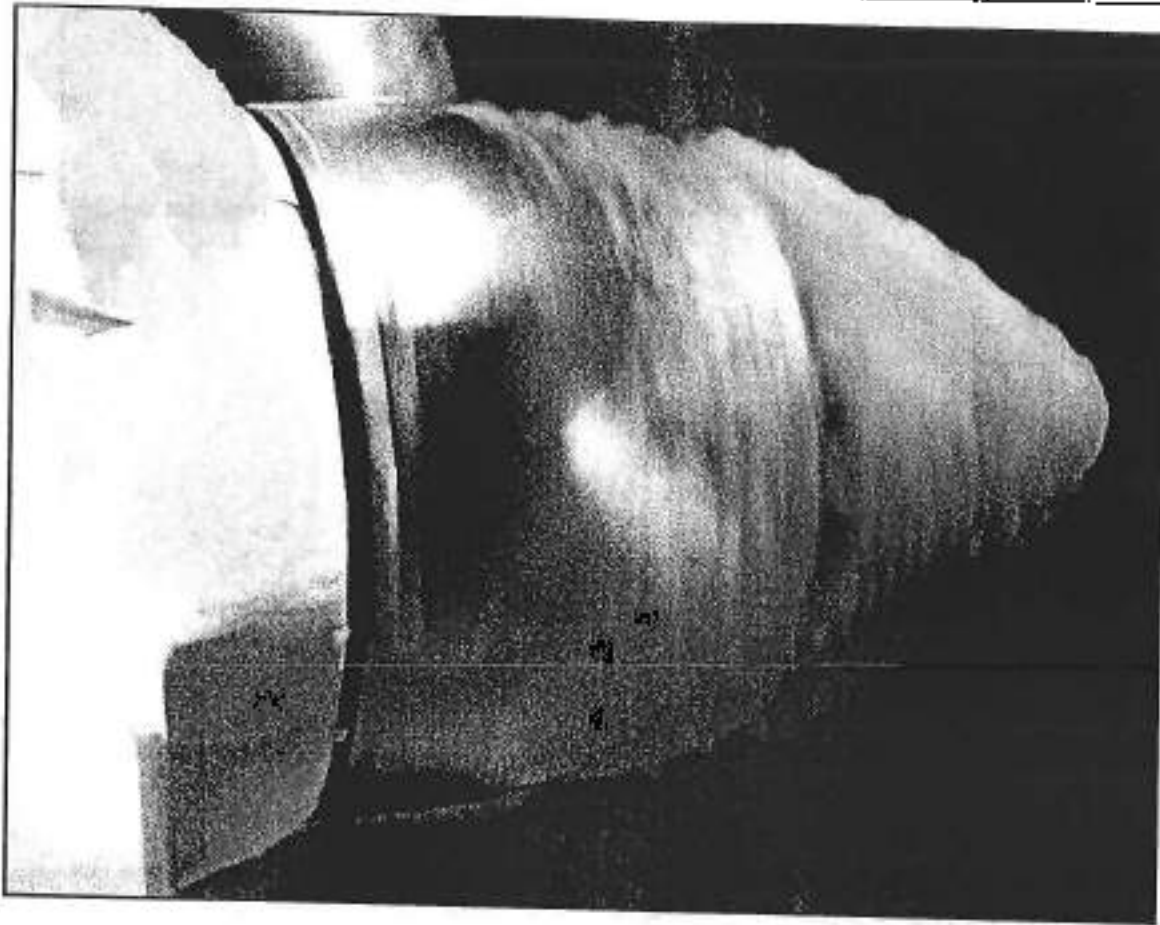
Figure I-9

MU-2B left propeller spinner in SLD. Ice extends aft to propeller blade roots. Appendix C ice covers approximately the forward half of the spinner. Ice is visible on the indicated upper inlet surface.

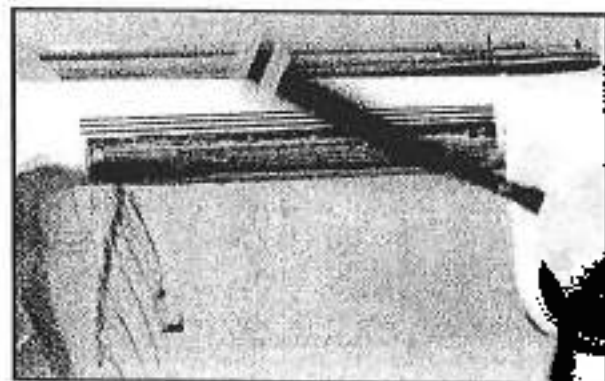
MU-2B in SLD. Asymmetry of ice accretion results from propeller wash effects with co-rotating propellers. Above left: Down-going blade decreases AOA resulting in more aft-wise impingement on upper surface. Above right: Up-going blade increases AOA aft resulting in less aft-wise impingement on upper surface. The light green color (seen in both figures above) at the stagnation line is liquid water.

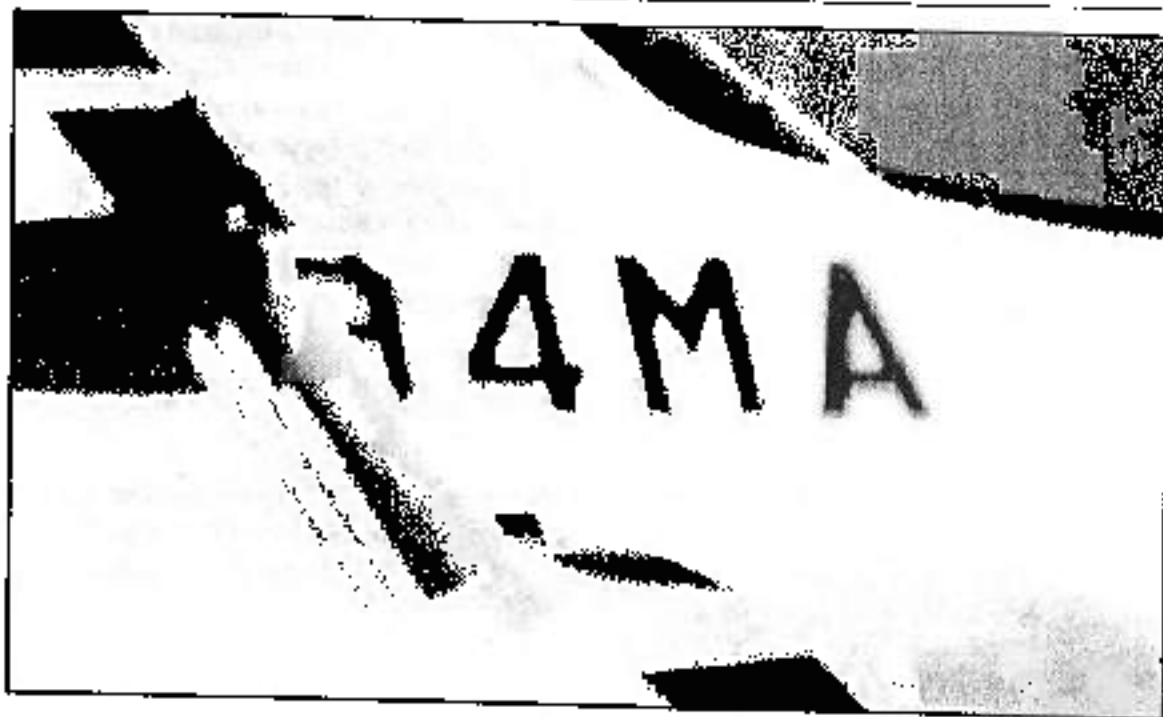
Figure 1-14

MU-2B right stabilizer in SLD. Ice can be seen extending approximately 10 inches further outboard than the left stabilizer (figure 1-15 below). Observe ice on the leading edge of the vertical stabilizer.

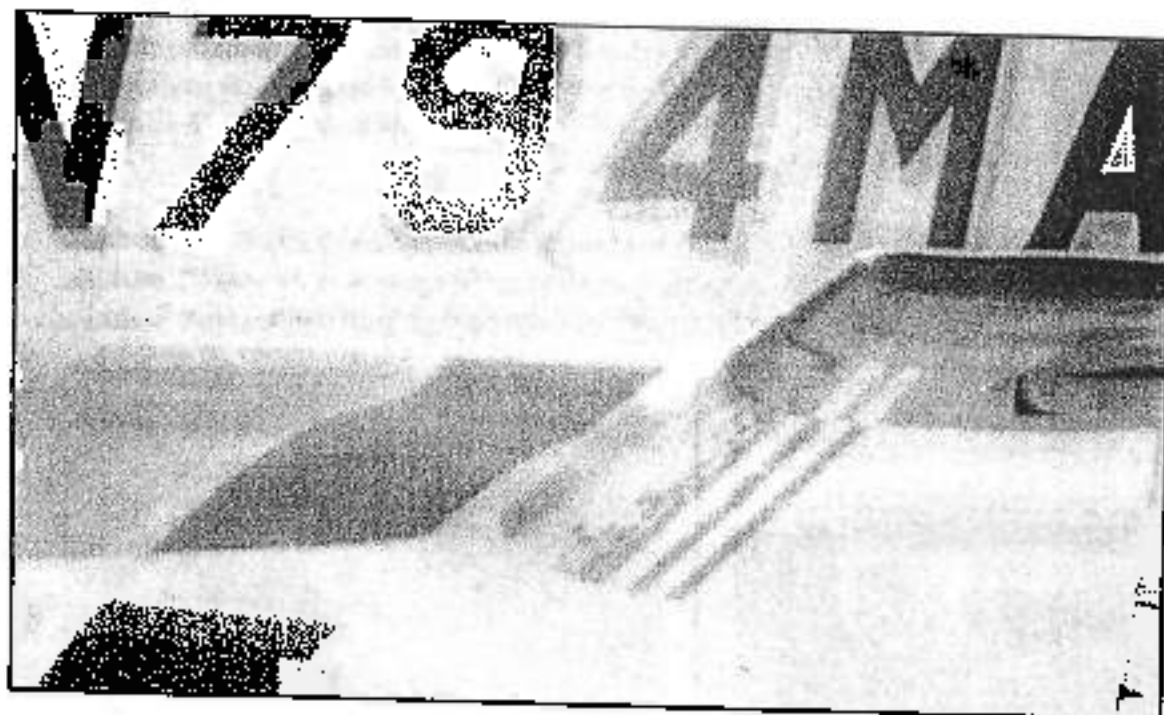
Figure 1-15

MU-2B left stabilizer in SLD. Ice does not extend as far outboard as the right stabilizer. Distributed roughness elements are visible aft of the Eddy but to lesser extent than the right stabilizer.

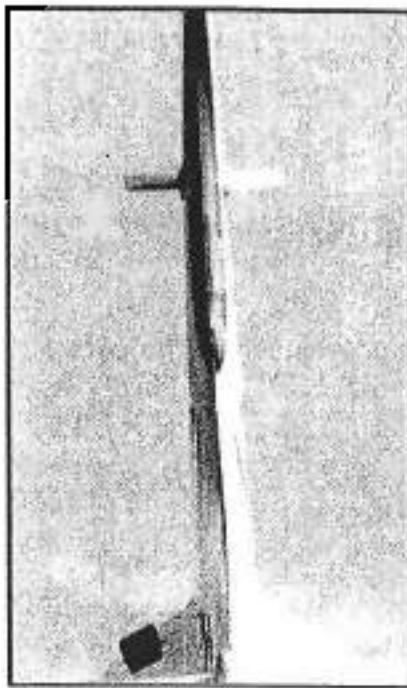
*Figure I-16
Ice on the vertical stabilizer is not
symmetric due to propeller wash
effects.*

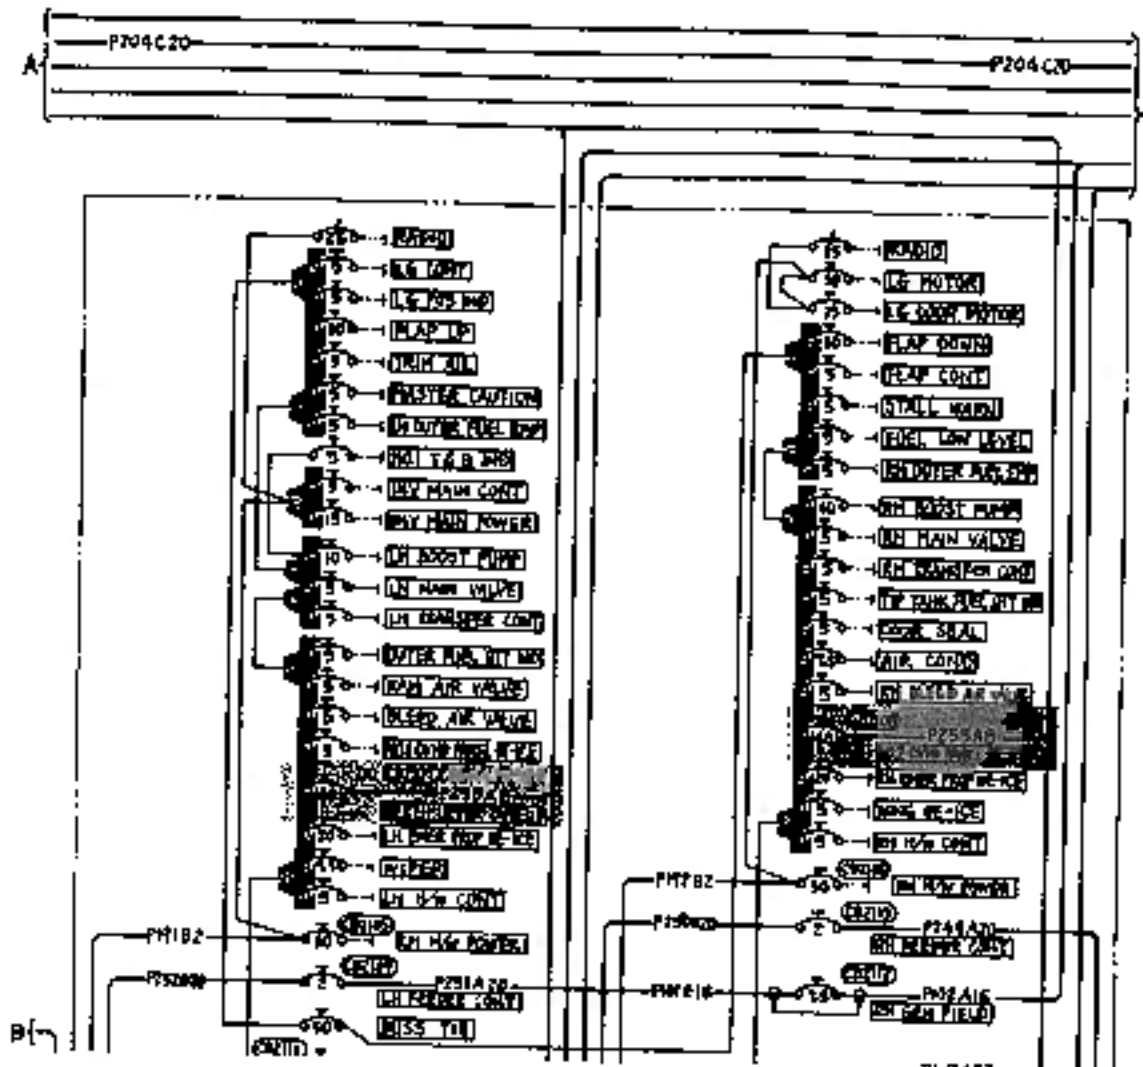
found acceptable previously, they have agreed to modify the anti/de-ice system circuit protection by eliminating CB2107 and CB2108.

1. Recommend a service bulletin be issued by MHI to require the installation of a water trap/drain valve in the tail de-ice manifold pressure line, and require that the system be drained during each 100 hour inspection. If the line accumulates water through condensation or flight through rain, the line may freeze and render the tail boots inoperative.
2. An open failure of a single circuit breaker for icing systems results in loss of capability of four essential anti/de-ice systems and should be corrected. Issue an AD to remove Circuit Breakers CB2107 and CB2108 for the essential systems that are protected by combination switch/circuit breakers.
