Federal Aviation Administration
Aircraft Certification Service
Small Airplane Directorate

**MITSUBISHI HEAVY INDUSTRIES
MU-2B SERIES AIRPLANE
FFFSR REPORT**

JUNE 27, 1997

**FAA/JCAB FACT FINDING FOCUSED SPECIAL
CERTIFICATION REVIEW TEAM**

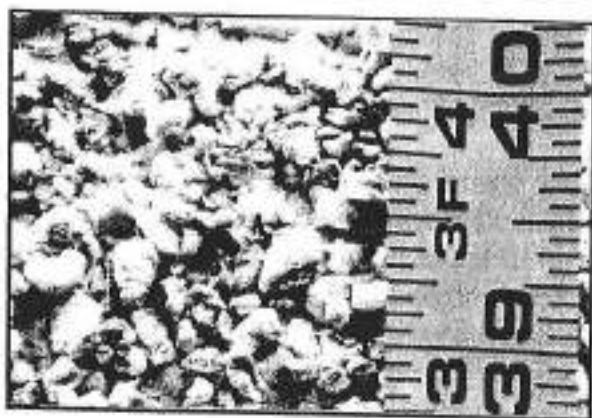
Figure 1-18

Above left: Artificial roughness elements approximately 3 to 5 mm in diameter.

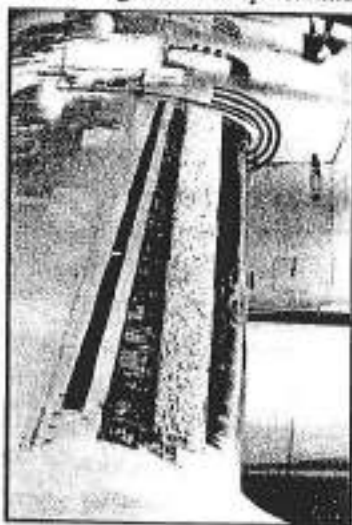
Figure 1-20

Simulated roughness elements, right wing leading edge.

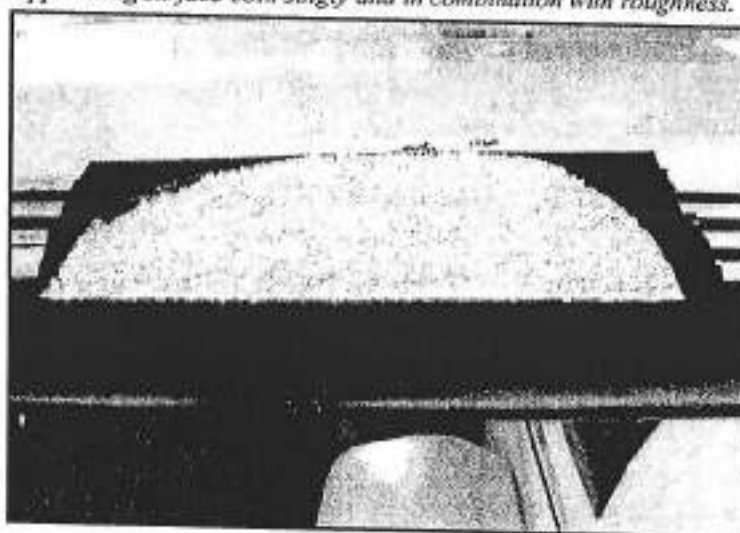
Figure 1-21

Artificial roughness elements on right inner wing simulates texture and asymmetric accretion.

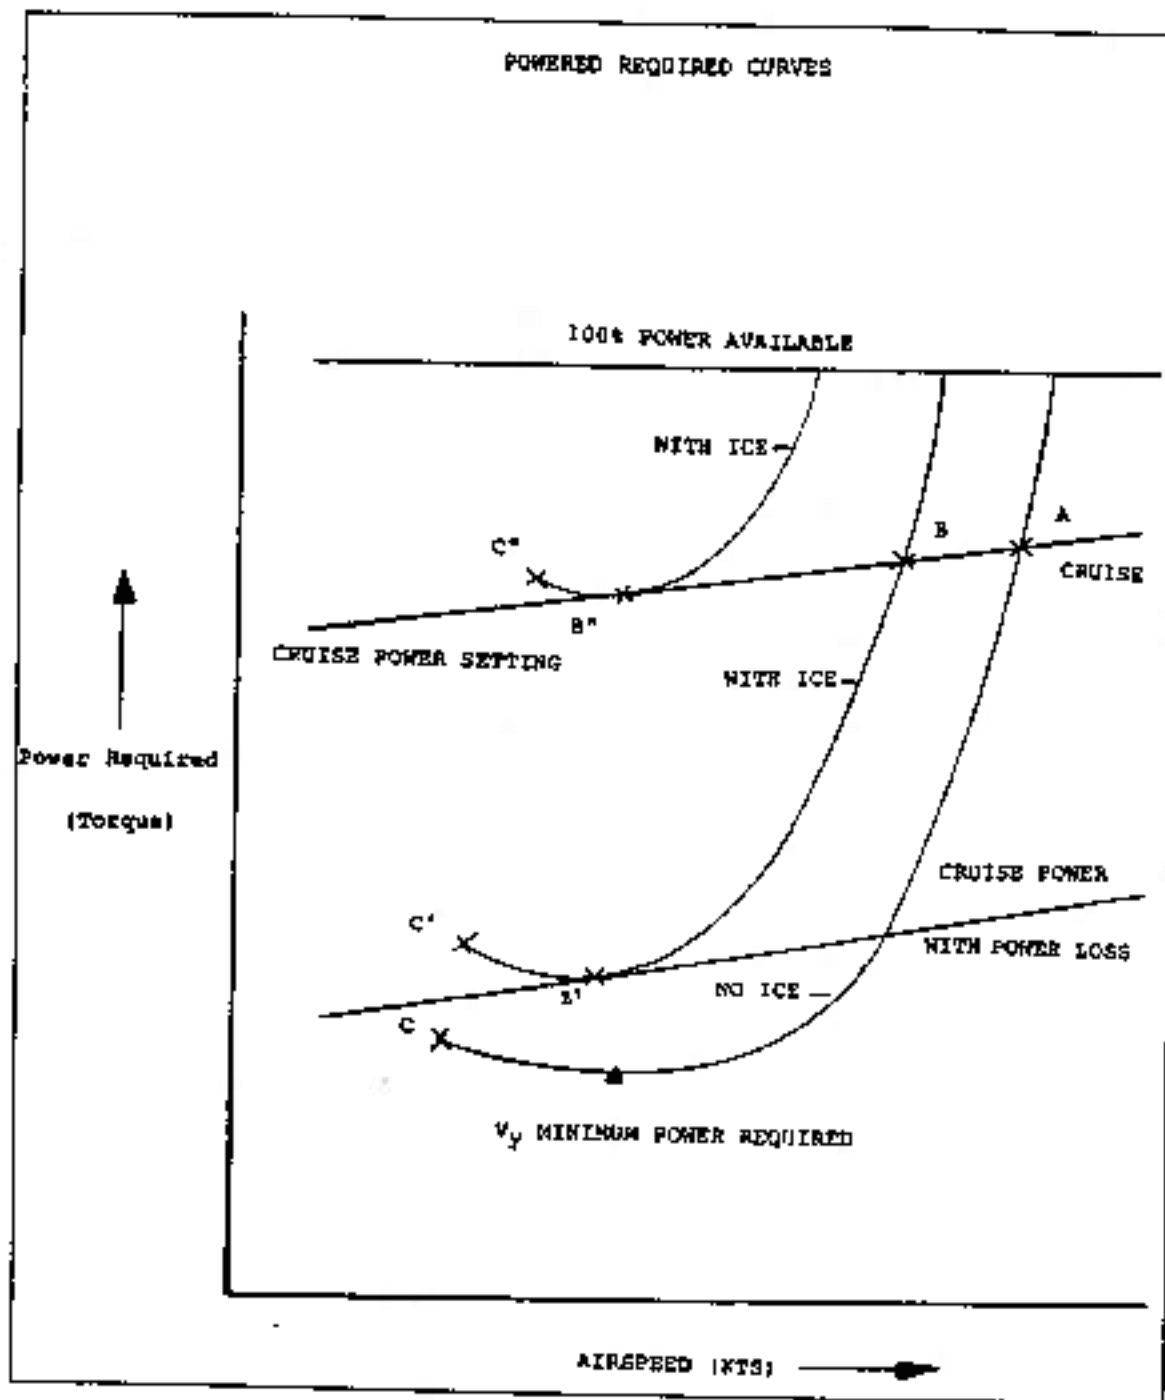
Figure V-1, Power Curve

If the airplane is in cruise flight at point A on the curve and icing conditions are now encountered that are beyond the capability of the de-ice systems, the ice accumulation will cause a loss of lift and an increase in drag. Both of these conditions will cause the airplane to sink or lose altitude and slow it down. If the autopilot is engaged and in the ALT Hold mode, the autopilot will not let the airplane sink, but will increase the elevator nose up trim to maintain the altitude (increases the AOA on the wing). This will result in a new airspeed, lower than the original airspeed, at a new nose up trim position (point B on the curve). As more ice is accumulated, the airspeed will decrease as before, but if the airplane sustains a power loss for whatever reason, the slowdown occurs much faster, and can result in a case where the power is just below the minimum power required for level flight, point B'. If no power loss is sustained, a very large increase in drag is required to reach the minimum power required, point B'' on the curve. If these airspeeds are reached, different things start to happen. As can be seen on the curve, the slower the airplane flies, the more power is required to hold altitude until stall is reached, and the airplane can no longer stay at this altitude (point C on each curve). Note. Additional power is available for the pilot to use to accelerate or climb. However, if the pilot does not add power, the nose up trim will run almost continuously until stall occurs.

In actual flight operation, the ice accumulation will change the shape of the curve and raise the curve as shown by the dashed lines. The ice will cause an elevated stall airspeed depending on the shape, roughness, and extent of the ice, as well as the use or non-use of the de-ice boots. Stall airspeeds, as high as 45 knots above normal have been reported (FAA certification data without de-ice boot activation) with a large ice accumulation. Stall speeds with wing SLD ice shapes determined from the FFFSCR tanker testing resulted in an increase of only 14 knots.
