Service Instruction Number SIN2975 Revision C

Installation, Maintenance, and Repair of the KAflex® Rotor Brake Kit for the Bell 206 A/B and 206B3 Helicopter.

KAMATICS CORPORATION SERVICE INSTRUCTION NUMBER 2975

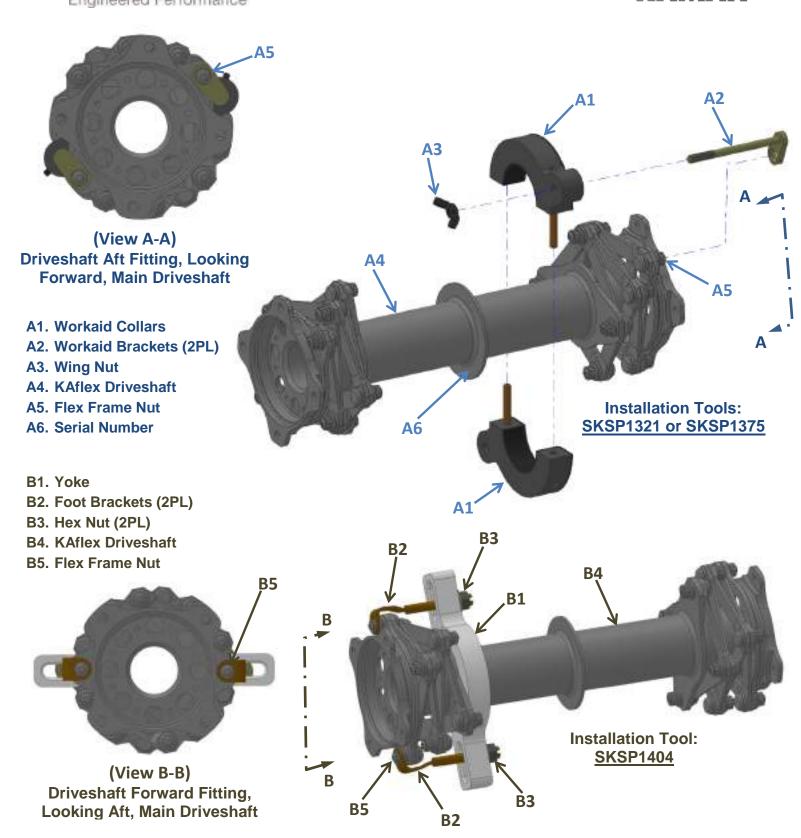
FIGURE 1: Installation of Workaid (Installation Tool SKSP1321, SKSP1375 or SKSP1404)

- c. If the caliper assemblies have not been brought in accordance with BHT Service Instruction Number 207-87-120, Dual Caliper Rotor Brake Assembly, Modification of, for removal of asbestos caliper pads, remove the calipers and make them compliant to the technical bulletin at this time.
- d. Install Workaid on driveshaft as shown in Figure 1 and compress forward frames.
- e. Remove clear rust inhibiting coating from SKCP2962 Rotor Brake Disk with acetone.

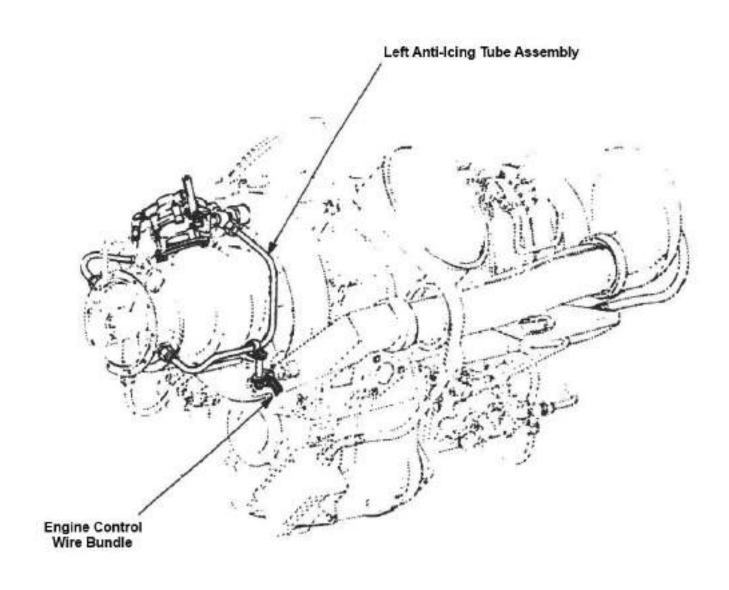
FIGURE 2: Optimum Location of Engine Control Wire Bundle on Left Anti-Icing Tube Assembly

- f. Install SKCP2962 Rotor Brake Disk on SKCP2967 Cup using 8 AN3-5A bolts and associated hardware as shown on View C Sheet 2 of SKCP2975 in Section 5.
- g. Refer to Figure 2. Loosen the wire clamp holding the engine control wire bundle to the left-hand anti-icing tube assembly shown in Figure 2. Slide the clamp aft as far as necessary to ensure that wires will not contact the rim of the KAflex Rotor Brake Disk. Verify that adequate wire slack still exists, and tighten clamp in the new position.

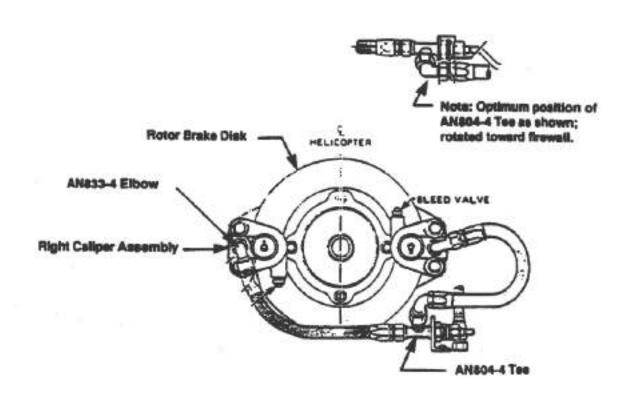
FIGURE 3: View Looking Aft at Rotor Brake

- a. Certain items must have their positions adjusted to allow clearance of the caliper assemblies upon reinstallation. Refer to Figures 3 and 4. Figure 3 shows the optimum position of the AN804-4 Tee. Verify that the tee is in this position, or loosen it just enough to allow slight rotation without permitting air to ender the hydraulic system at this fitting. If the aircraft does not have a particle separator installed, proceed to Step b at this point. Figure 4 shows the AN834-6Tee which connects the compressor bleed air line to 206-061-222-1 Tube Assembly across the firewall to allow this fitting to be installed in its most forward position. Reconnect the lines.

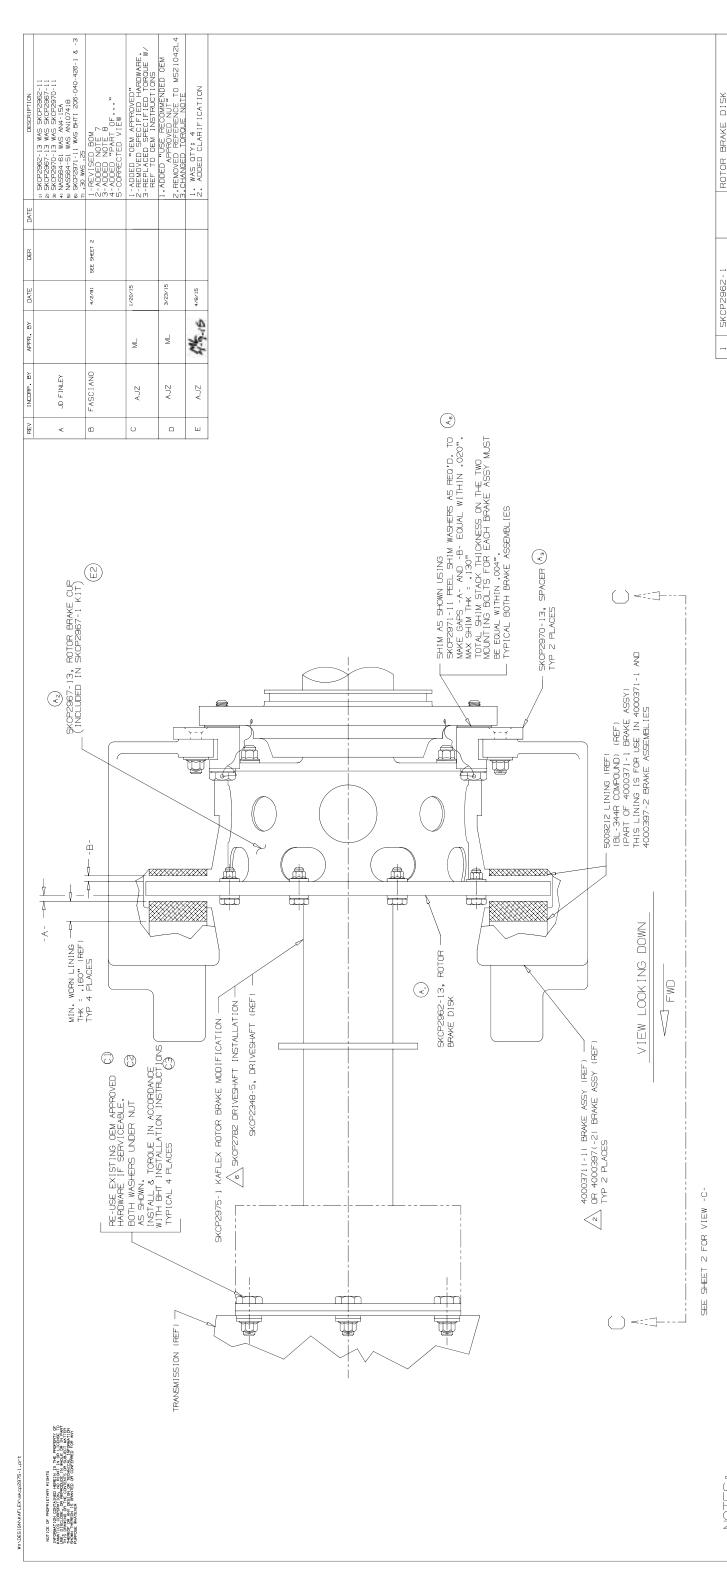
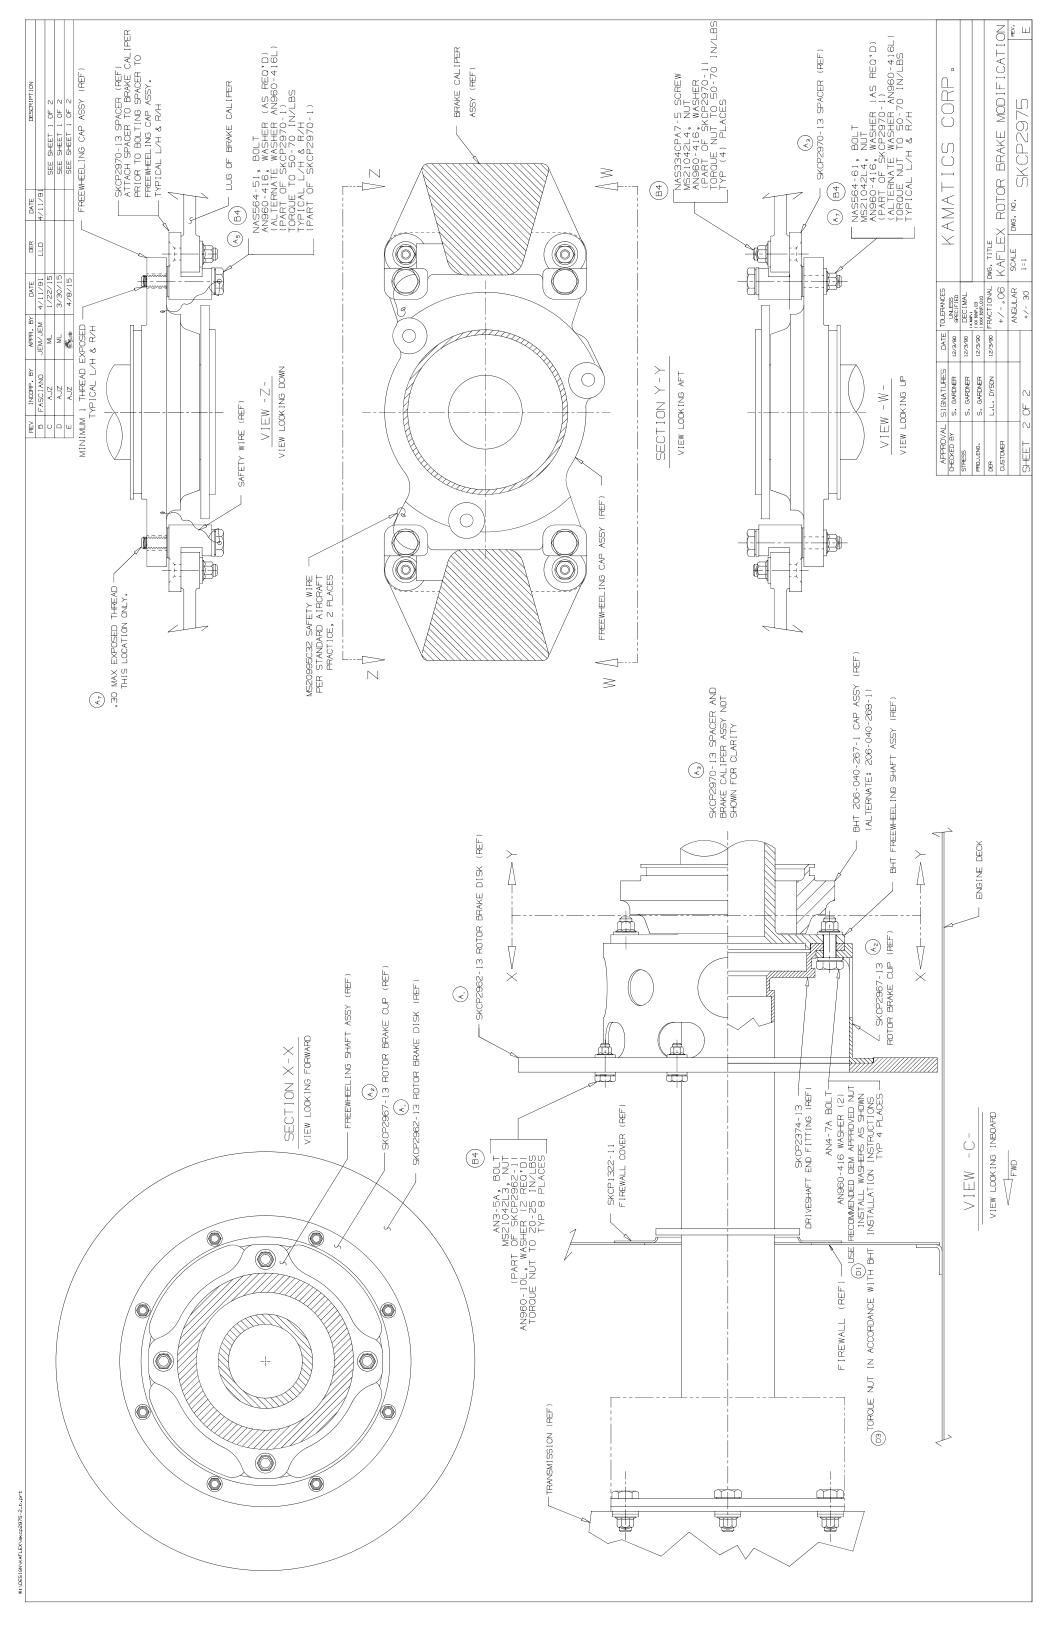
SKCP2975 SH 1,2

Following are copies of the Installation Drawing for STC SH7951SW.

The kit for use with this Service Instruction is in accordance with Installation Drawing SKCP2975 and consists of the items listed on SKCP2975 Sheet 1 (Bill of Material) in Section 5 of this Instruction. In addition, the kit includes an Historical Service Record (hard card), a Certificate of Conformance for the parts and a Flight Manual Supplement. The Historical Service Record and the Flight Manual Supplement are in a pocket in the rear cover of this Service Instruction. Please check parts before continuing.
