EXEC 162F MAINTENANCE MANUAL

The RotorWay EXEC 162F Maintenance Manual has been designed to provide the owner-operator the lowest operating cost possible while maintaining the flight characteristics and safety of their helicopter.

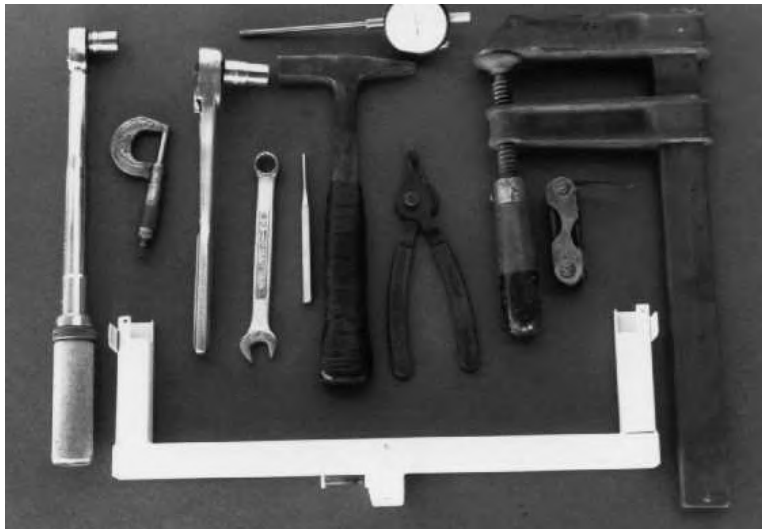
Photo #1: Tools required.

1. The following tools are required to perform the hub shimming procedures:
 - 3/8" torque wrench in ft. lbs. capable of 30-35 ft. lbs.
 - micrometer in thousandths of an inch
 - 3/8" drive ratchet with 9/16" socket
 - 9/16" box and open end wrench
 - 1/4" punch with a 3" shank
 - steel hammer and/or plastic hammer
 - snap-ring pliers that will fit the holes on the snap rings
 - spring scale
 - set of allen wrenches or at least one 1/4" and one 1/8" allen wrench
 - a clamp that spans the distance across the teeter blocks and has 4" jaws minimum
 - one rotor hub shimming fixture. See page 59 in this manual for a drawing of the fixture with dimensions and specifications. This fixture is also available from RotorWay, part number E08-6000.
 - one dial indicator with a 4" reach that reads in thousandths.

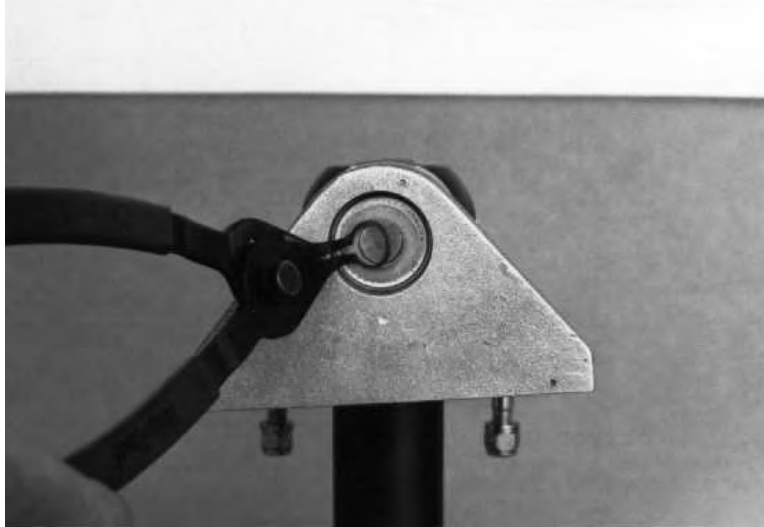
Photo #6: Remove snap rings.

8. Next remove the two snap rings and the large thin washer from the main drive pin. See photo #6.

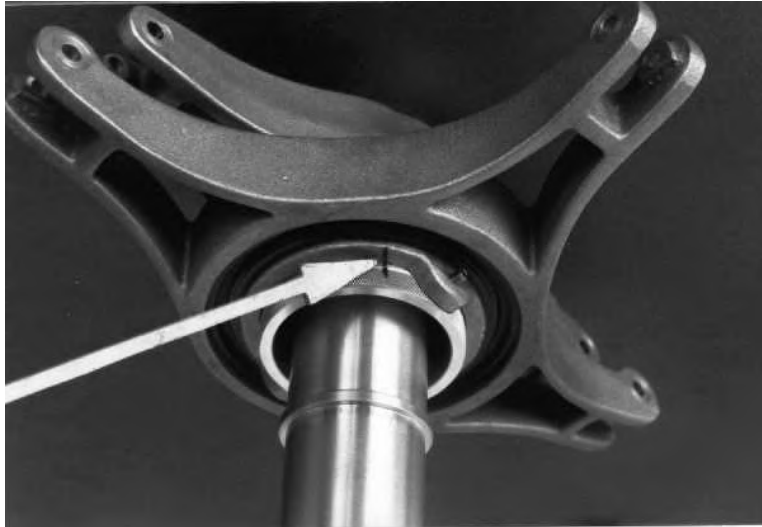
1. Using a protractor level, set the swash plate perpendicular to the main shaft. Rotating the blades may help you in achieving the fore and aft angles. If a protractor level is not available, centering the cyclic stick should place the swash plate at a relative perpendicular angle to the shaft. Loosen the two set screws (part no. E00-9302, Ref. 16 on print E49-2002) three full turns. With your fingers, loosen the adjustment collar approximately 2 full turns in a counter clockwise direction, until it can be turned easily. Again using your fingers, turn the collar in a clockwise direction until it comes to a stop. Make an index mark on the adjustment collar and non-rotating swashplate with a pencil or marker. Back off the adjustment collar counter clockwise 1/2". Then tighten the two set screws. See photos #14-16. Note: Use silicone on the set screws to help lock them in position and prevent them from backing out. Do NOT use loctite.

Photo #14: Placing an index mark.

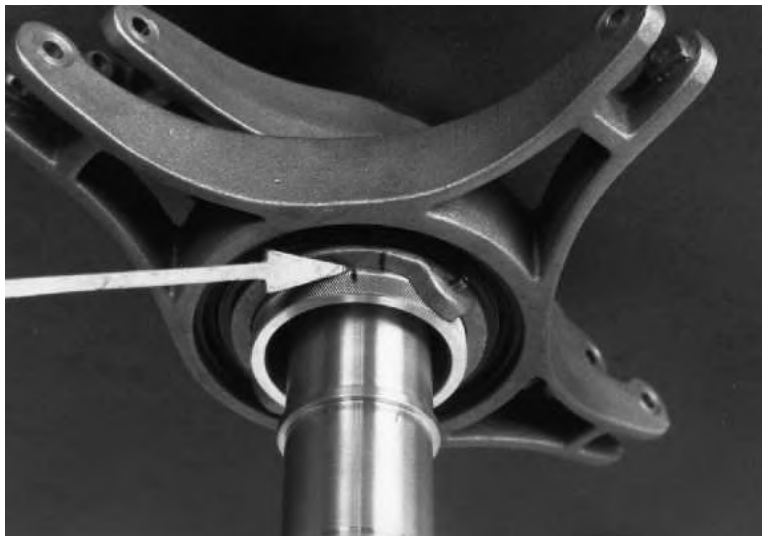
Photo #15: View after the collar has been backed off.

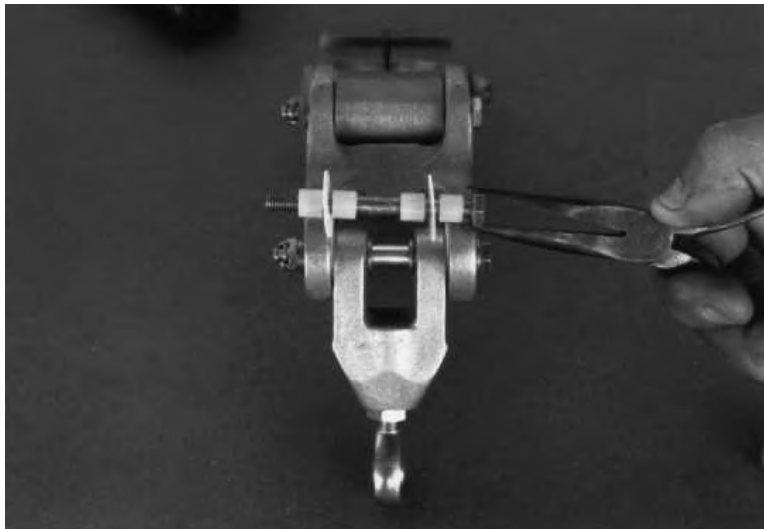
Photo #17: Position of bushings.

Photo #17 illustrates the positioning of the nylon bushings in the swash plate assembly. To determine if the castings need new bushings, measure the lateral deflection of the parts. If a total of .125 inch or greater is indicated, the nylon bushings should be replaced. The maximum the castellated nut should be tightened is two flats past finger tight. Further tightening may damage the aluminum castings.
